BUILDING COMMITTEE MEETING

FACILITY STUDY PRESENTATION

Facility Study Summary • October 19, 2020

MERCER COUNTY SCHOOL DISTRICT #404

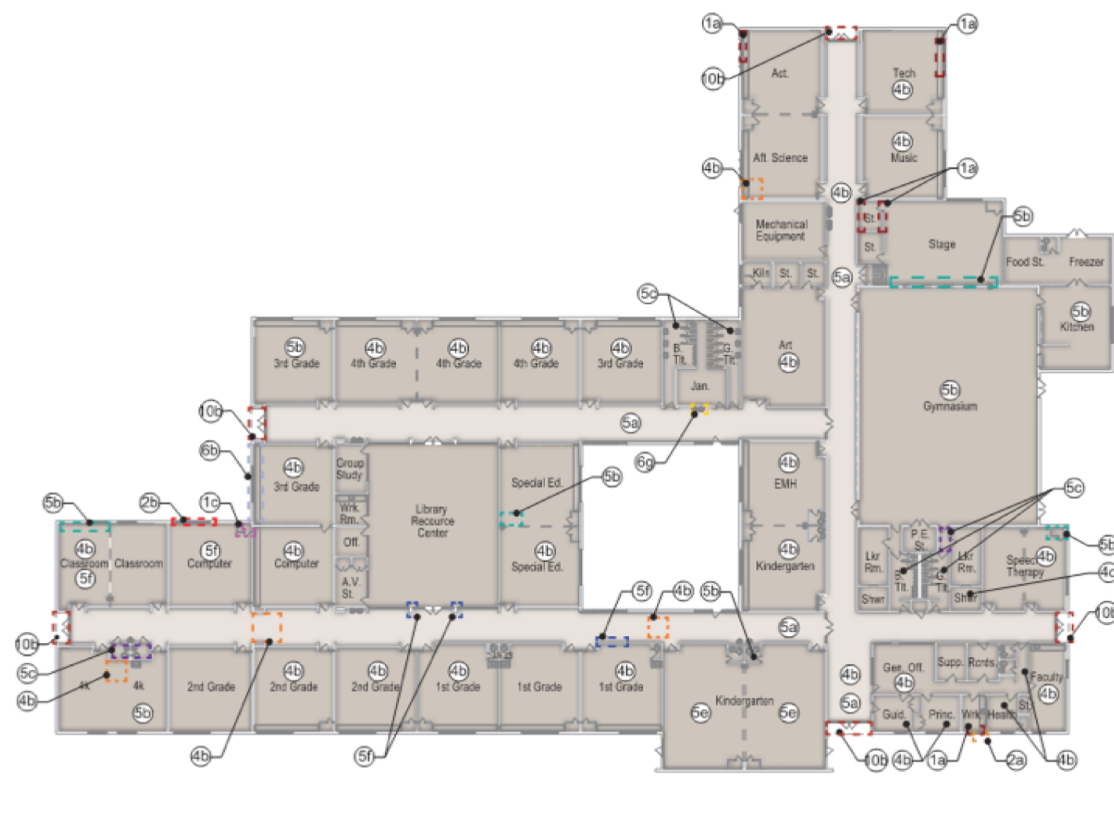
FIRST FLOOR PLAN
not to scale

No.	Apollo Elementary	Type / Material	Area / Location	Analysis	Identified in Plans
Infrastructure Improvement					
Building Interior					
1 Walls					
a	Walls	concrete	building	visible chipping, cracking, and peck fresh peeling.	x
b	Walls	tile	water fountain	instances of cracking, chipping and discolored tile.	
c	Walls	gypsum	corridor	rising gypsum around panel leaving insulation and wood studs exposed.	x
d	Walls	brick	corridor	instance of chipped corner.	
2 Window Interior & Openings					
a	Interior Window Sills	stone	building	visible cracking and chipping.	x
b	Interior Window Lintels	metal	building	visible discoloration.	x
c	Interior Storefronts	hollow metal	office / library	visibly worn and scratched.	
3 Interior Doors					
a	Interior Door / Frame	wood / hollow metal	building	visible chipping, scratching of door, and rusting of frame especially near base; doors with updated hardware have wood infill pieces where old hardware existed.

b	Interior Doors / Frame	aluminum / aluminum	library / gymnasium	visibly worn and scratched.	
c	Interior Doors / Frame	hollow metal / hollow metal	office	overall in good condition.	
d	Interior Doors	acoustic partition / vinyl fabric	classrooms	visibly dated, worn and torn.	
e	Interior Doors	aluminum roll-up	kitchen	visibly worn.	
4 Ceilings					
a	Ceilings / soffits	-	-	-	-
b	Ceilings	building	acoustical tile	visible staining, warping, broken / cracked / instances of gouging / missing tiles; instances of discoloration or grid flexures.	x
c	Ceilings	showers	plaster	paint peeling and instances of missing paint.	
5 Flooring					
a	Flooring	VCT (green / yellow)	corridors	visibly worn w/ patched tiles.	
b	Flooring	VCT (white)	building	visibly worn w/ patched, and broken tiles; cracking, chipping, and missing tiles; spot staining especially in lobbies and classrooms #7.	x
c	Flooring	tile	toilet rooms	patched tiles; visible grout discoloration; visible tile cracking.

d	Flooring	concrete	janitor / mechanical	spot staining.	
e	Flooring	carpet	classrooms	visibly dated, ripped, worn.	x
f	Base	vinyl	building	worn, peeling, discolored and instances of missing sections.	x
6 Miscellaneous					
a	Casework w/ sink	wood w/ laminate counter	classrooms	visibly dated, wood is worn, and chipped. Laminate is worn and swollen.	
b	Casework	metal w/ contact paper adhered to metal counter	classrooms	visibly dated, worn, and scratched; contact paper peeling and missing at instances.	x
c	Casework w/ sink	metal w/ sink basin	classroom #9	visibly dated, worn, scratched and rusted.	
d	Toilets	porcelain	toilet rooms	overall good condition.	
e	Bathroom Stall Partitions	plastic	toilet rooms	overall good condition.	
f	Grab Bars	metal	toilet rooms	visibly rusting and discolored.	
g	Drinking Fountains	metal	corridor	visibly worn, rusting and fresh peeling.	x
h	Walls	metal	classroom	visibly worn, rusted, and dented.

i	Desk Back	wood	corridor	visibly worn.

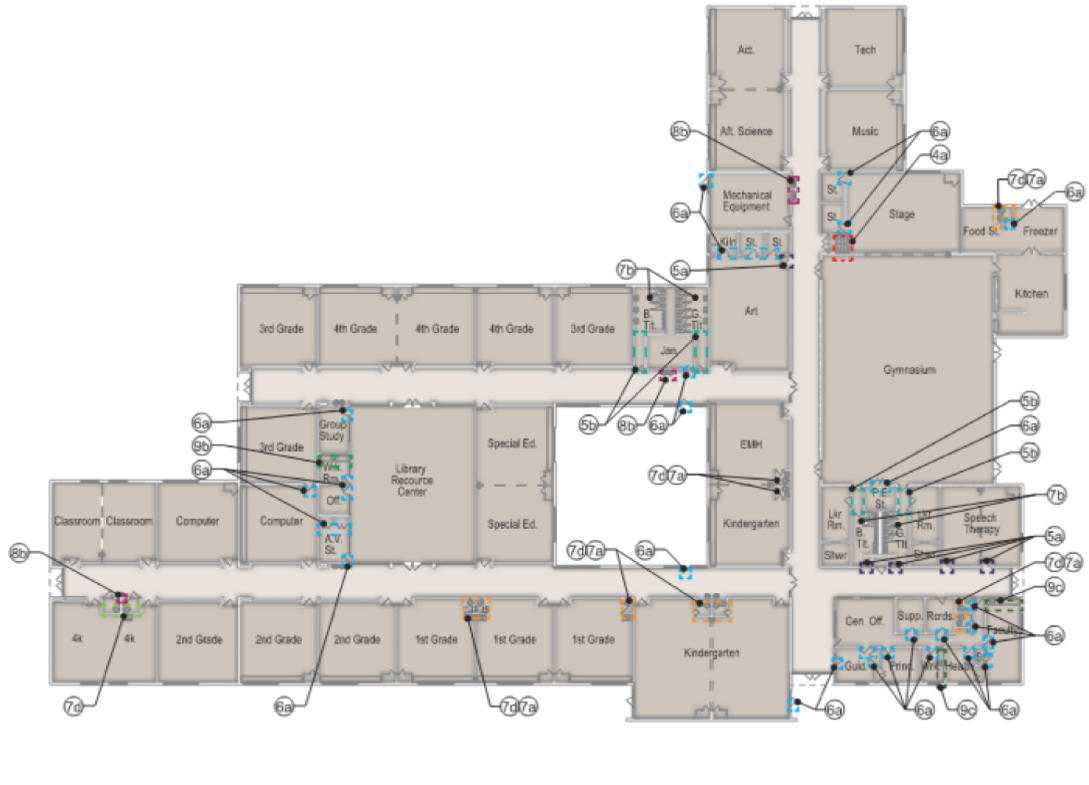
FIRST FLOOR PLAN
not to scale

No.	Apollo Elementary	Area / Location	Analysis	Potential Solution	Identified in Plans
ADA Accessibility					
1	Building Entrance				
a	Accessible Route of Travel	building	there are ADA compliant accessible routes of travel into the building	none	
2	Parking				
a	ADA Parking Stalls	west parking lot	there are designated ADA compliant stalls	none	
3	Ramps & Lifts				
a	Accessible Routes of Travel Between Floor Levels - Ramps				
b	Accessible Routes of Travel Between Floor Levels - Lifts				
c	Accessible Routes of Travel Between Floor Levels - Elevators				
4	Railings				
a	Stair Railings	stage	ADA compliant standards for railings are not met	remove / replace to provide ADA compliant railings	x
b	Ramp Railings				
5	Maneuvering, Thresholds, & Push / Pull				
a	Push / Pull	building	ADA compliant standards for push/pull are not met	renovate as needed	x
b	Maneuvering	building	ADA compliant standards for maneuvering are not met	renovate as needed	x

c	Thresholds				
6	Door Hardware				
a	Door Hardware	building	door hardware is not ADA compliant	replace as needed	x
7	Restrooms				
a	5'-0" wheelchair Clearance	building	ADA compliant standards for wheelchair clearance are not met	renovate as needed to provide ADA compliant standards for wheelchair clearance	x
b	ADA Accessible Stall	building	ADA compliant stall is not provided	renovate as needed to provide at least (1) ADA compliant stall for the group restroom	x
c	Unisex Restrooms	building	at least (1) ADA compliant unisex restroom is not at this floor level	renovate as needed to provide at least (1) ADA compliant unisex restroom at this floor level	x
d	Grab Bars	building	ADA compliant standards for grab bars are not met	renovate to provide ADA compliant grab bars; wall relocation required to meet ADA compliant dimension requirements	x
e	Showers				
8	Drinking Fountains & Protruding Objects				
a	Drinking Fountains	building	ADA compliant

b	Protruding Objects	building	ADA required wing walls are not present at ADA compliant standards for wing walls are not met.	renovate / relocate as needed to provide ADA compliant standards	x
9	Casework, Transaction Counters, & Counters with Sinks				
a	Transaction Counters	library	ADA compliant		
b	Workstation Counters	building	does not contain at least 3'-0" length of workspace at ADA compliant height	provide 3'-0" length of counter / workspace at ADA compliant height	x
c	Counters with Sinks	building	does not contain at least 3'-0" length of counters with sinks at ADA compliant height	provide 3'-0" length of counter with sink at ADA compliant height	x

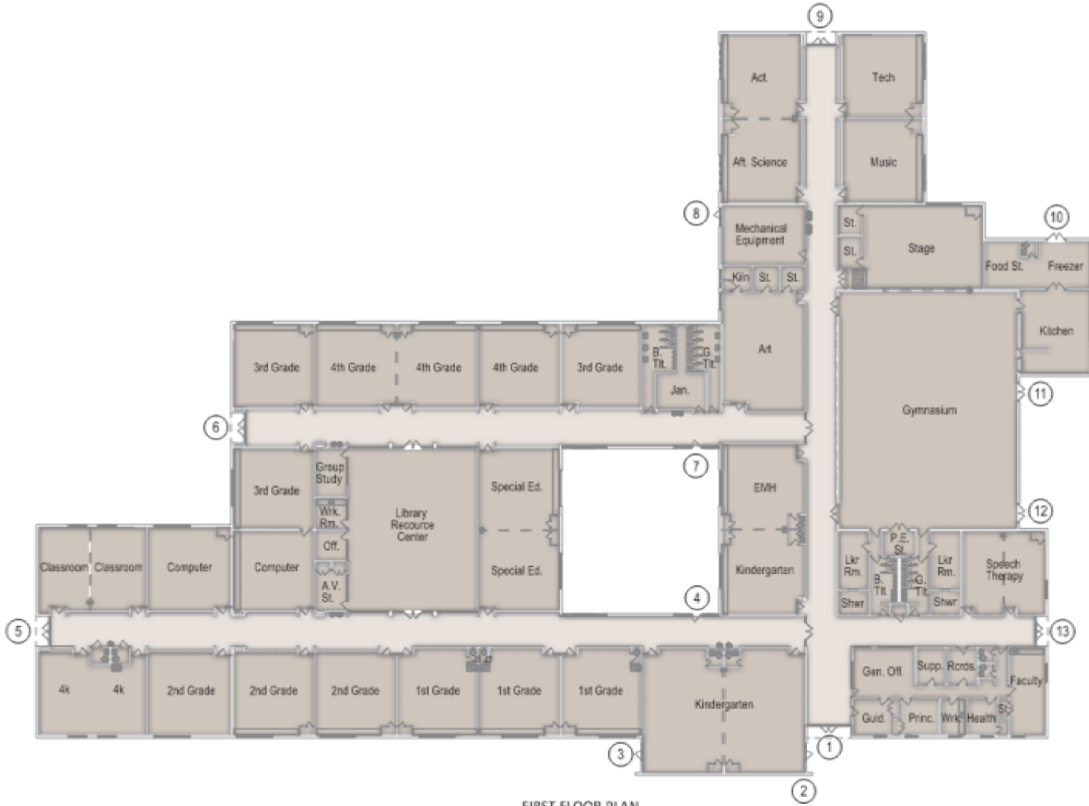
FIRST FLOOR PLAN
not to scale

Apollo Elementary			
No.	Door Type	Frame Type	Visual Condition
1	Aluminum	Aluminum Storefront	Good
2	Hollow Metal	Hollow Metal Storefront	Fair
3	Hollow Metal	Hollow Metal Storefront	Poor
4	Fiber Reinforced Plastic	Wood	Good
5	Hollow Metal	Hollow Metal Storefront	Good
6	Hollow Metal	Hollow Metal Storefront	Good
7	Fiber Reinforced Plastic	Wood	Good
8	Hollow Metal	Hollow Metal	Fair
9	Hollow Metal	Hollow Metal Storefront	Fair
10	Hollow Metal	Hollow Metal	Good
11	Hollow Metal	Hollow Metal	Good
12	Hollow Metal	Hollow Metal	Good
13	Hollow Metal	Hollow Metal Storefront	Good

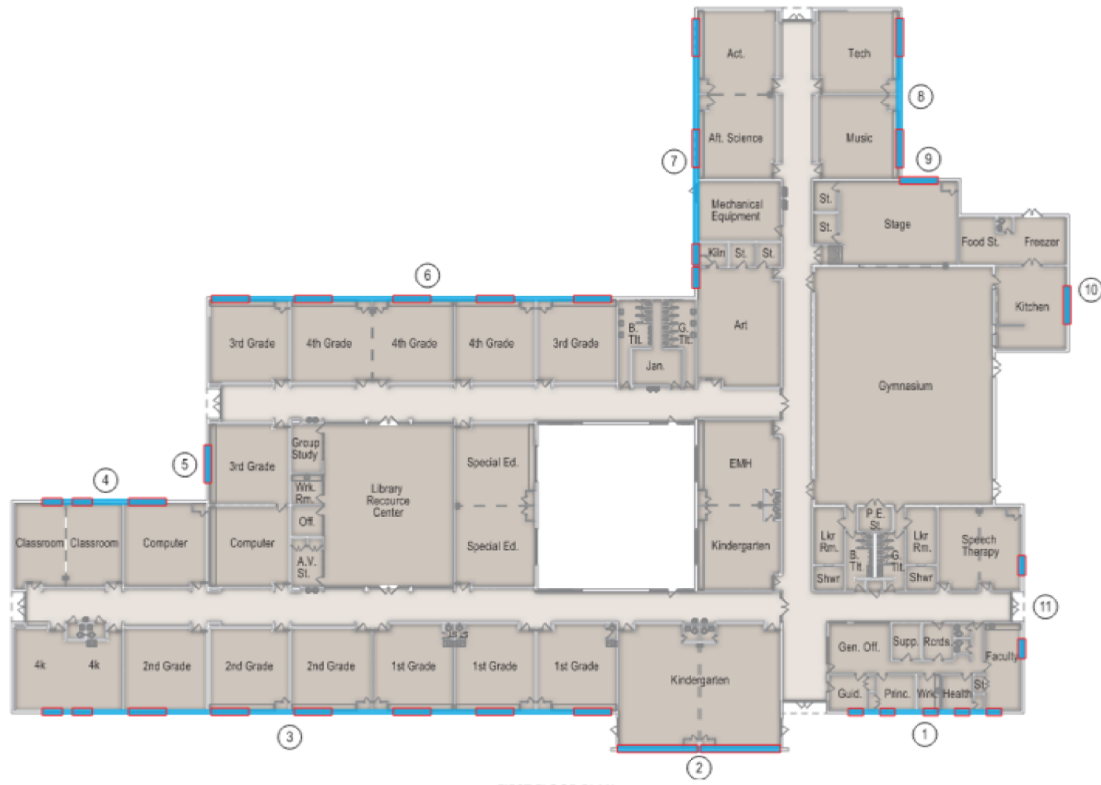
FIRST FLOOR PLAN
not to scale

Apollo Elementary		
No.	Window Type	Consider Replacement
1	Aluminum w/ Single Pane	Replace Single Pane w/ Double Pane
2	Aluminum w/ Single Pane	Replace Single Pane w/ Double Pane
3	Aluminum w/ Single Pane	Replace Single Pane w/ Double Pane
4	Aluminum w/ Single Pane	Replace Single Pane w/ Double Pane
5	Aluminum w/ Single Pane	Replace Single Pane w/ Double Pane
6	Aluminum w/ Single Pane	Replace Single Pane w/ Double Pane
7	Aluminum w/ Single Pane	Replace Single Pane w/ Double Pane
8	Aluminum w/ Single Pane	Replace Single Pane w/ Double Pane
9	Aluminum w/ Single Pane	Replace Single Pane w/ Double Pane
10	Aluminum w/ Single Pane	Replace Single Pane w/ Double Pane
11	Aluminum w/ Single Pane	Replace Single Pane w/ Double Pane
